# Manhole Inspection Summary

Manhole # S43A2\_024MH

Insp Date: **12/10/07 9:12 AM**

**Location** Address: **3744 10th St**

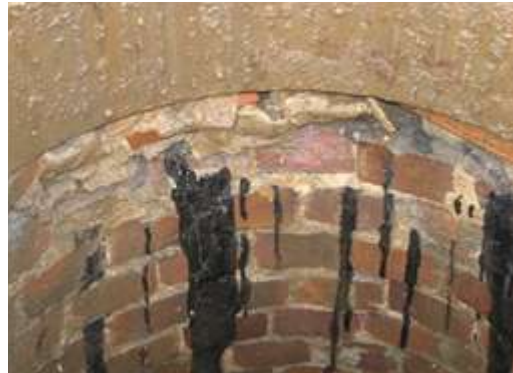
Defect 1

Condition: ☐ Sound ☐ Cracked ☐ Root Intrusion ☒ **Loose Brick** ☐ Deteriorated

Infiltration: ☐ None ☐ Joint ☐ Cracks ☒ **Mortar** ☐ Roots ☐ Wall

Loose bricks/mortar

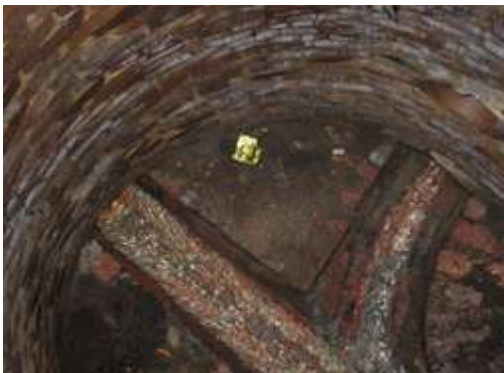
Defect 2

Debris

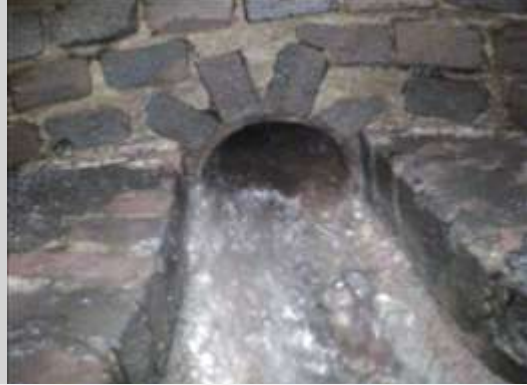
12 O'Clock Outflow

Pipe Height: **9.6** (in.) Rod and Bar (Angled)  
Pipe Material: **Clay** ☐ Pipe Lined  
Invert Depth: **10.26** (ft.) Flow Characteristics: **Fast**  
Deposits: ☒ None ☐ Mud ☐ Sludge ☐ Debris ☐ Grease  
Silt Depth: (in.) Deposits Extent:  
Infiltration: **None** Pipe Seal Cond: **Sound**

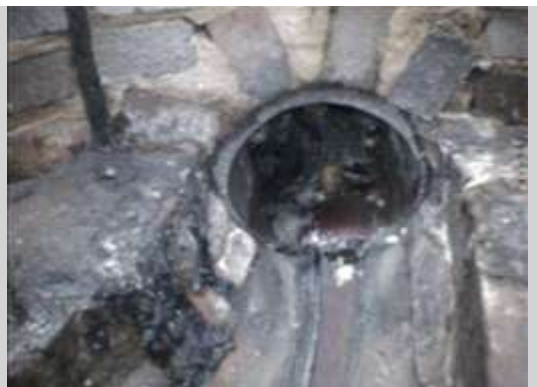
4 O'Clock Inflow

Pipe Height: **8.4** (in.) Rod and Bar (Angled)  
Pipe Material: **Clay** ☐ Pipe Lined  
Invert Depth: **9.97** (ft.) Flow Characteristics: **Fast**  
Deposits: ☒ None ☐ Mud ☐ Sludge ☐ Debris ☐ Grease  
Silt Depth: (in.) Deposits Extent:  
Infiltration: **None** Pipe Seal Cond: **Sound**

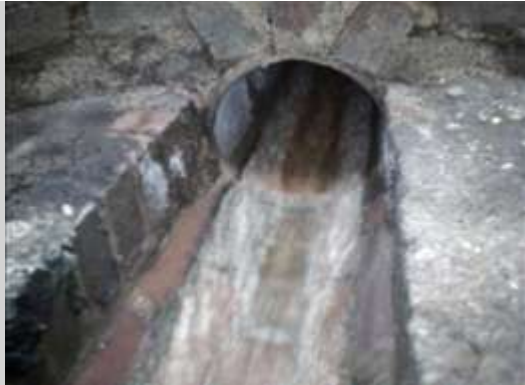
6 O'Clock Inflow

Pipe Height: **9.6** (in.) Rod and Bar (Angled)

Pipe Material: **Clay** ☐ Pipe Lined

Invert Depth: **10.10** (ft.) Flow Characteristics: **Fast**

Deposits: ☒ None ☐ Mud ☐ Sludge ☐ Debris ☐ Grease

Infiltration: **None** Pipe Seal Cond: **Sound**

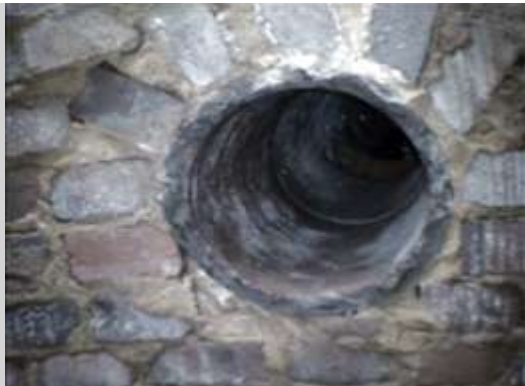
8 O'Clock Inflow

Pipe Height: **9.6** (in.) Rod and Bar (Angled)

Pipe Material: **Clay** ☐ Pipe Lined

Invert Depth: **7.64** (ft.) Flow Characteristics: **Fast**

Deposits: ☒ None ☐ Mud ☐ Sludge ☐ Debris ☐ Grease

Infiltration: **None** Pipe Seal Cond: **Sound**

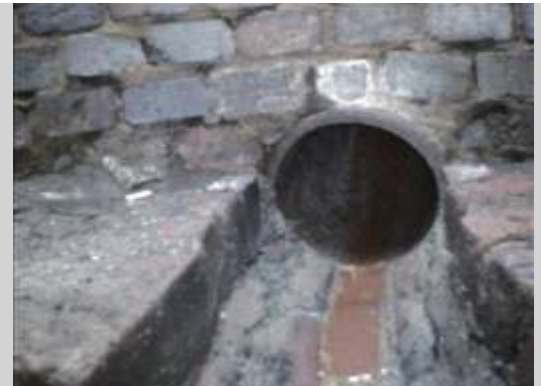
Drop In @ 8 O'Clock

Drop: **Outside** Rod and Bar  
Angled: **Yes** Reading: **8.82** (ft.)  
Inv Depth: **9.82** (ft.)

Drop Condition: **Open**
